Cargo Damage (Scratches on Pipes & Pipes Damage on Protect Cap)

At Umm Qasr Port

Joint Survey Report

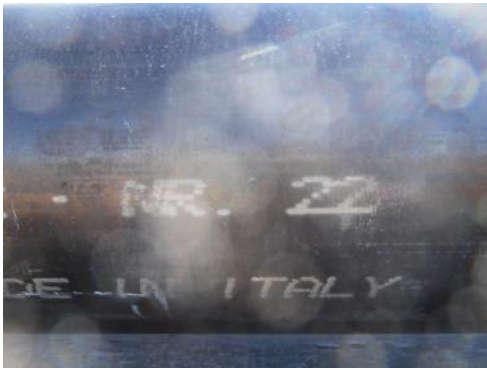
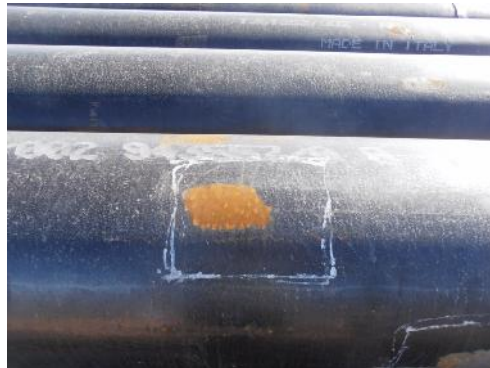
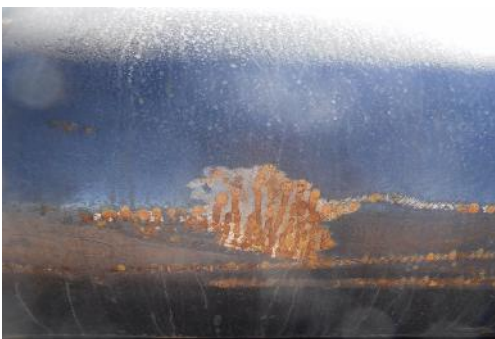
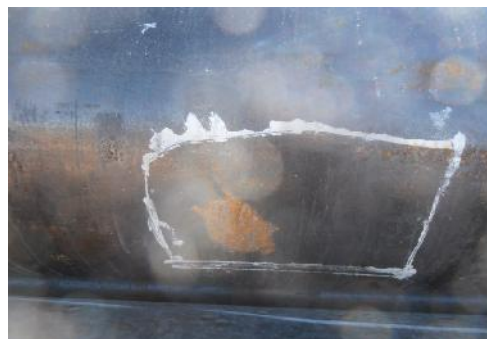
- 1- Pipe No. 22 , scratches on pipe only. See Photos group no.1
- 2- Pipe No. 197 , dents, and scratches on the protections caps only. See Photos group no.2

Undersigned attendance parties have given due consideration to the survey findings and to the damages sighted at the time of survey, on this basis we are of the opinion that the cause of damage to the pipes can fairly and reasonably be attributed to poor stow and mishandling of cargo at some stage of shipment.

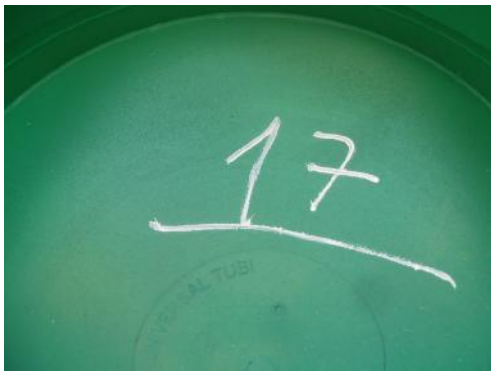
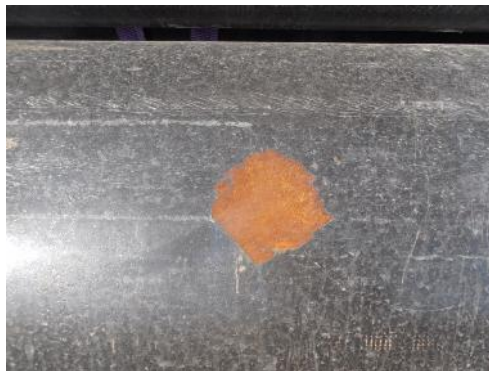
- 3- Pipe No. 17 , scratches on pipe only. See Photos group no.3
- 4- Pipe No. 165 , scratches on pipe only. See Photos group no.4
- 5- Pipe No. 207 , dents on the protections caps about 9cm. See Photos group no.5

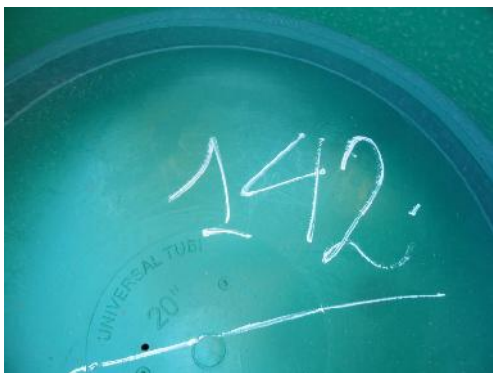
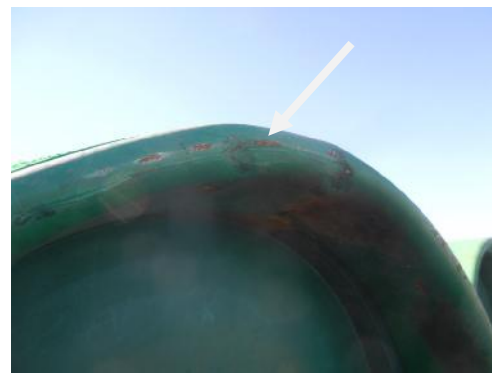
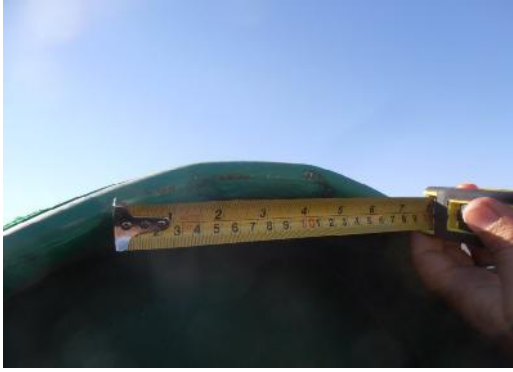
- 6- Pipe No. 142 , dents, and scratches on the protections caps about 12cm. See Photos group no.6
- 7- Pipe No. 210 , dents, on the protections caps only. See Photos group no.7

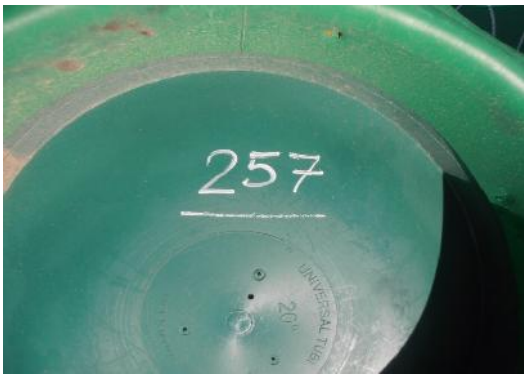
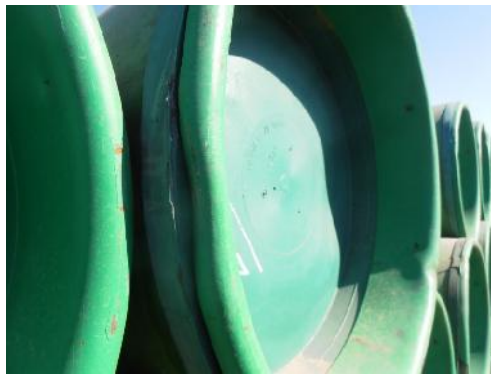
- 8- Pipe No. 257 , dents, on the protections caps only about 3cm. See Photos group no.8
- 9- Pipe No. 146 , dents, on the protections caps only about 12cm. See Photos group no.9

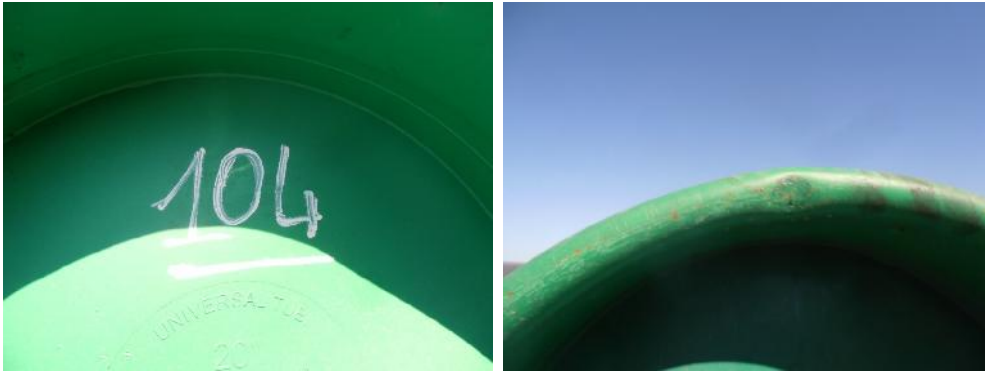
- 10- Pipe No. 104 , dents, on the protections caps only about 10cm. See Photos group no.10
- 11- Pipe No. 255 , dents, on the protections caps only about 7cm. See Photos group no.11

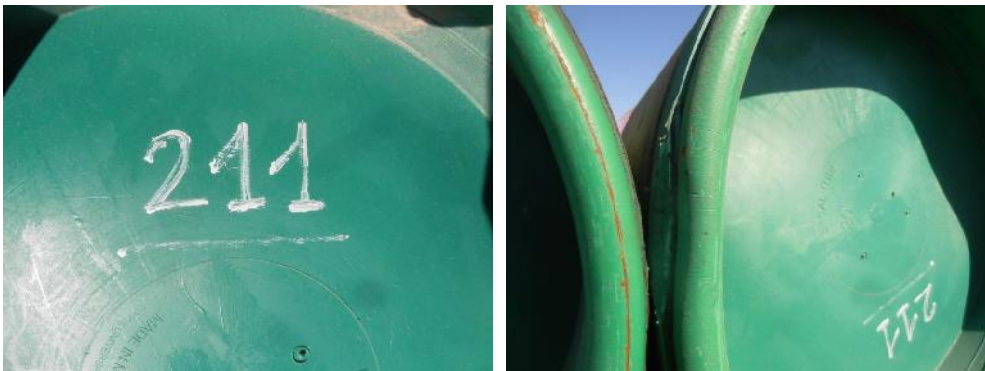
- 12- Pipe No. 211 , dents, on the protections caps only. See Photos group no.12
- 13- Pipe No. 119 , dents, on the protections caps only about 20cm. See Photos group no.13

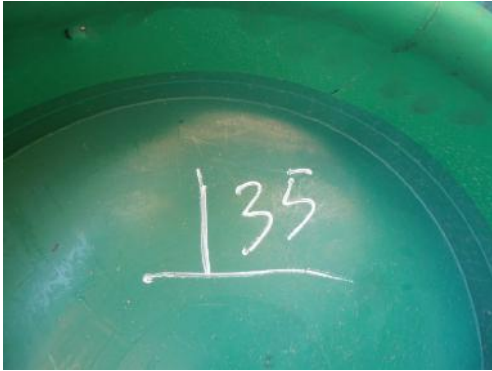
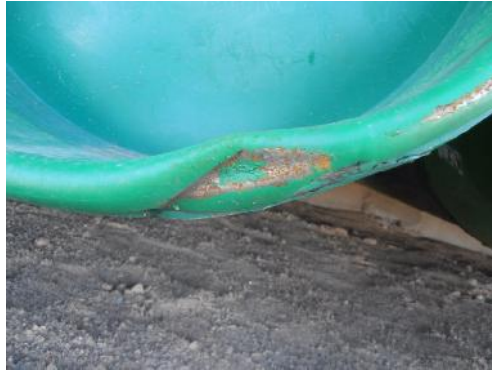
- 14- Pipe No. 135 , dents, on the protections caps only about 10cm. See Photos group no.14
- 15- Pipe No. 137 , scratches on the protections caps only about 5cm. See Photos group no.15

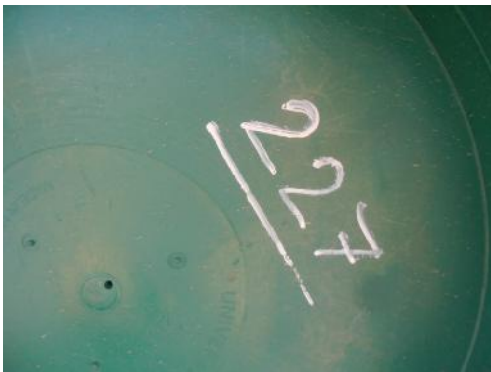
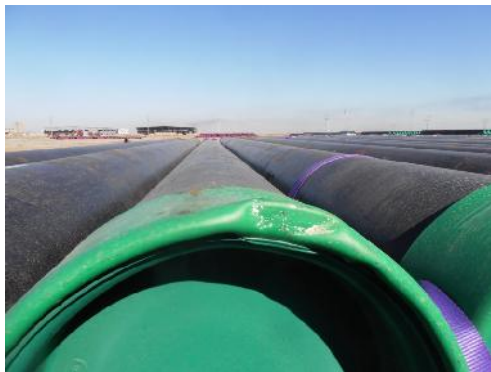
- 16- Pipe No. 227 , dents, on the protections caps only about 10cm. See Photos group no.16
- 17- Pipe No. 76 , scratches on the protections caps only about 12cm. See Photos group no.17
