**Damage report
MV THAMESBORG**

Kindly note that we attended on board the ship on today 15.01.2015 at 1500 hrs in order to investigate the alleged damage of the Package no. 6-10 (Power Car No.150B), met ship's Master , Chief Officer.& Agent

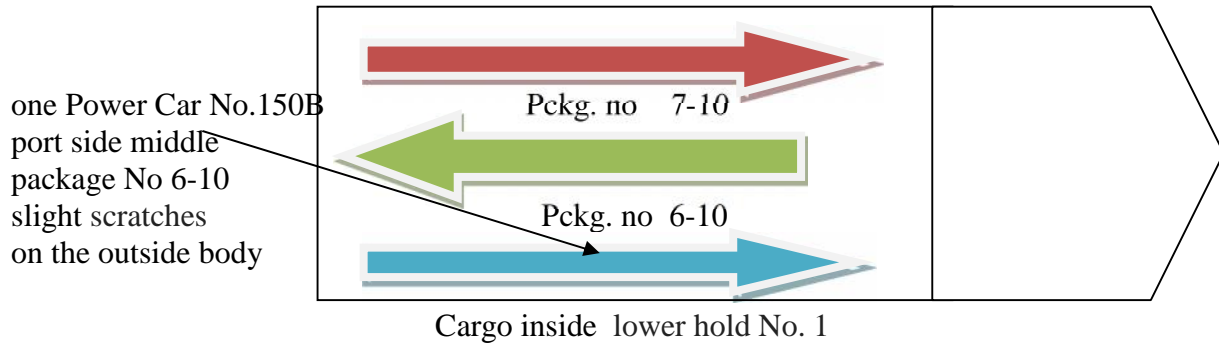
As the ship's master stated , Caused the damage on 14.01.15 at 1330 hrs , at the moment of lifting the Package no. 7-10 of lower hold No. 1, because of the lifting equipment for the Package no. 7-10 touch the Package no. 6-10 from port side package caused slight scratches on the outside body. See below diagram.

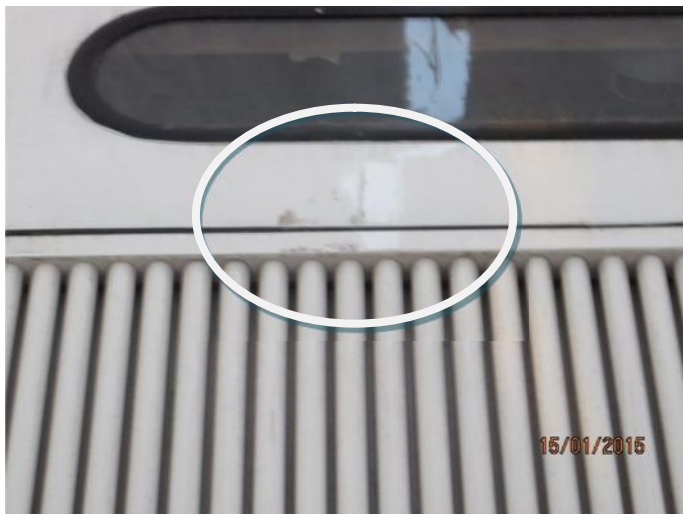
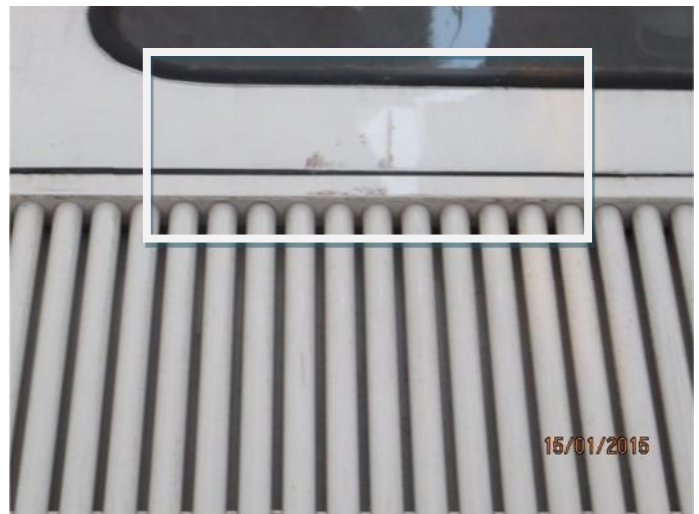
Pictures no.1

- 1- Top damage about 10 cm x 15 cm slight scratches . see picture no.1
- 2- Middle damage White color about 10 cm x 1 cm slight scratches . see picture no.2
- 3- Middle damage red color about 13 cm x 1 cm slight scratches . see picture no.3
- 4- Lower damage about 30 cm x 4 cm deep scratches . see picture no. 4
- 5- Lower damage about 22 cm x 4 cm slight scratches . see picture no. 5
