**Damage report
MV THAMESBORG**

Kindly note that we attended on board the ship on today 15.01.2015 at 1500 hrs in order to investigate the alleged damage of the Package no. 6-10 (Power Car No.150B), met ship's Master , Chief Officer.& Agent

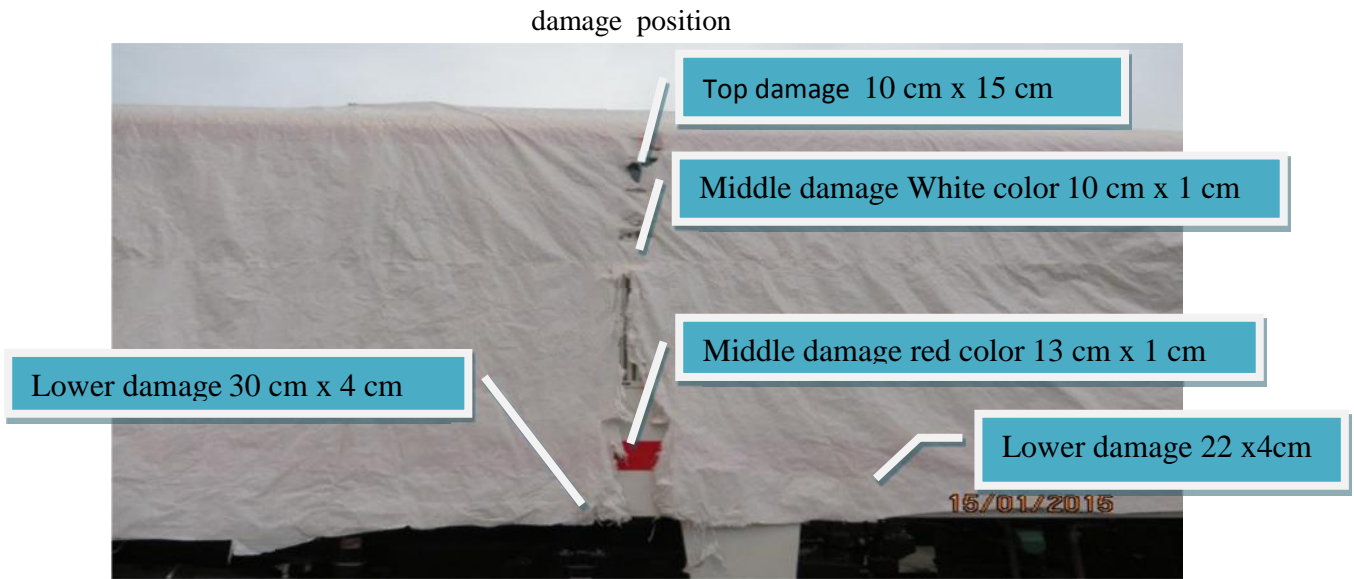
Pictures no.1

- 1- Top damage about 10 cm x 15 cm slight scratches . see picture no.1
- 2- Middle damage White color about 10 cm x 1 cm slight scratches . see picture no.2
- 3- Middle damage red color about 13 cm x 1 cm slight scratches . see picture no.3
- 4- Lower damage about 30 cm x 4 cm deep scratches . see picture no. 4
- 5- Lower damage about 22 cm x 4 cm slight scratches . see picture no. 5
